Manhole Inspection Summary

Manhole # S11AA2005MH

Location Address: **2422 BRIARWOOD RD** Cross Street: **ROCKSPRING RD**

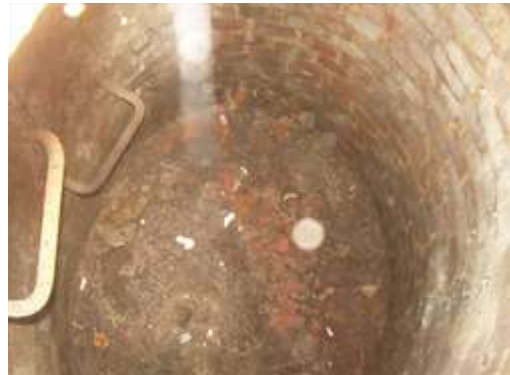
Top View

Manhole Type: **Terminal** Location: **Roadway** Ground Conditions: **Dry**
☐ Prev. Rehab Weather: **Dry** Subject To Ponding: **None**
Comments **Cracks in pavement around manhole. O12 pipe picture indicates evidence of infiltration through the mortar of the Barrel wall.**
